Middleby Cooking Systems Group

Return of TP44 and TP120 Support and Elevator Assemblies with broken Roller Cam Pins.

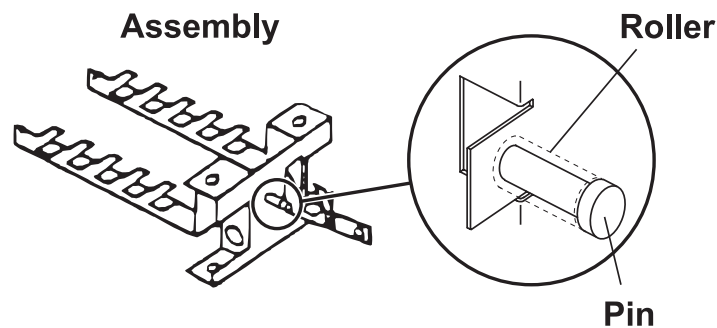
Toastmaster Service has become aware of a potential weakness in the Roller Cam Pin located on the Support and Elevator Assembly (P/N 760-6059) for the TP44 and TP120 Slot Toasters. The Assembly, Pin, and Roller are shown in the drawing below.

To help in diagnosing and correcting this weakness, Toastmaster Service requests that all Support and Elevator Assemblies from these toasters that are found with broken Roller Cam Pins during servicing be returned to Toastmaster Service.

When replacing a Support and Elevator Assembly (P/N 760-6059) on an affected Pop-Up Toaster *that is still covered under its service warranty*, check the status of the Roller Cam Pin. If the pin is broken or loose, please return the entire Assembly to Toastmaster Service. If the pin is unbroken and securely attached to the Assembly, discard the Assembly as per the normal replacement procedure.
